SERVICE BULLETIN NO. SB-114-36

DATE JULY 3, 2017

INSPECTION OF MAIN LANDING GEAR BRAKE TORQUE PLATE ASSEMBLY BOLT INSTALLATION

MODELS AFFECTED: Model 114, S/N 14000 thru 14442; Model 114A, S/N 14500 thru 14540;
Model 114B, S/N 14541 thru 14666; Model 114TC, S/N 20001 thru 20038

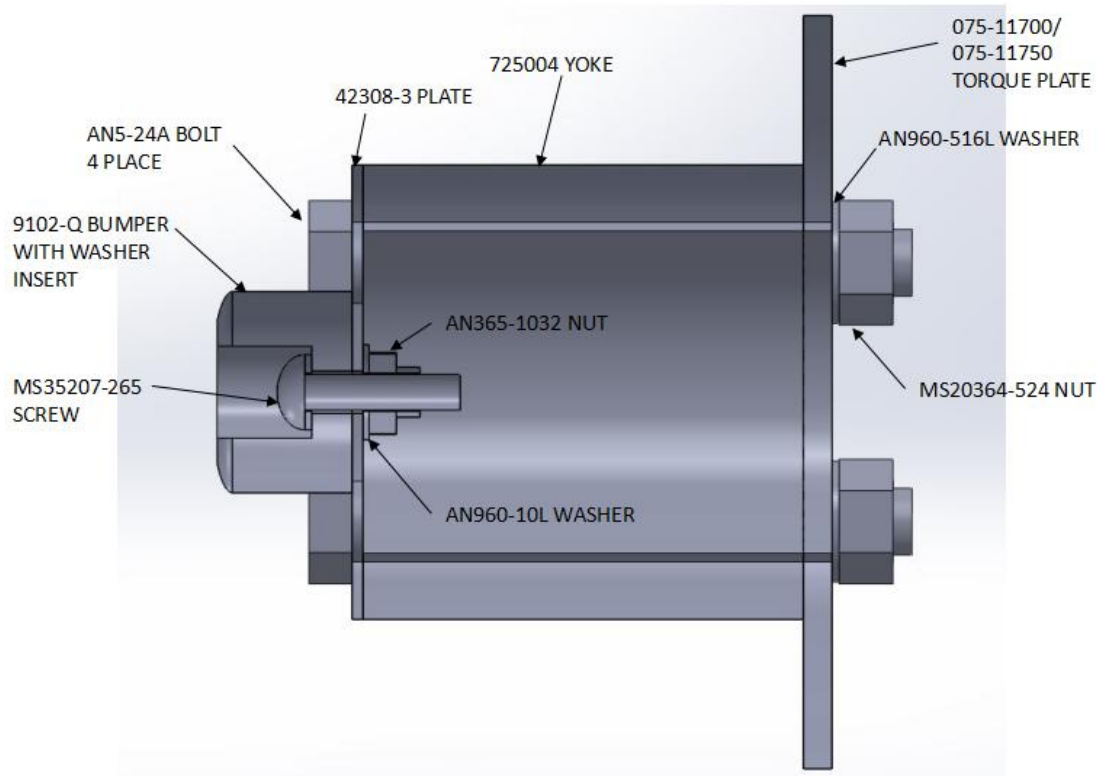
Figure 1

Determine that the AN5-24A bolts(4) are installed with the bolt heads on the inboard side of the Main Landing Gear yoke, common to the 42308-3 Plate(Refer to figure 1). Using an inspection mirror, determine

that AN960-516L washers and MS20364-524 nuts are installed with a minimum of 1 thread through the nut. If minimum thread protrusion is showing, no further change is required.

4. If minimum thread protrusion is not showing, replace the bolt(s) with AN5-25A bolts.
5. If bolt ends and nuts are showing on the inboard side of the Main Landing Gear yoke, the bolts must be reversed in order to provide required clearance between the Main Landing Gear and wing structure. Possibility of interference between bolt(s) with excess thread protrusion and structure must also be avoided.

Bolt thread protrusion through the nut on the now reversed bolts must be a minimum of 1 thread through the nut. For assembles without minimum thread protrusion, replace bolts using AN5-25A bolts.

Torque all bolts per the Model 114B/114TC Maintenance Manual (60-85 IN-LBS above running torque).
