SERVICE BULLETIN NO. SB-112-74

DATE JULY 3, 2017

INSPECTION OF MAIN LANDING GEAR BRAKE TORQUE PLATE ASSEMBLY BOLT INSTALLATION

MODELS AFFECTED: Model 112/112B, S/N 3 thru 544 and 13000; Model 112TC/112TCA, S/N
13001 thru 13309;

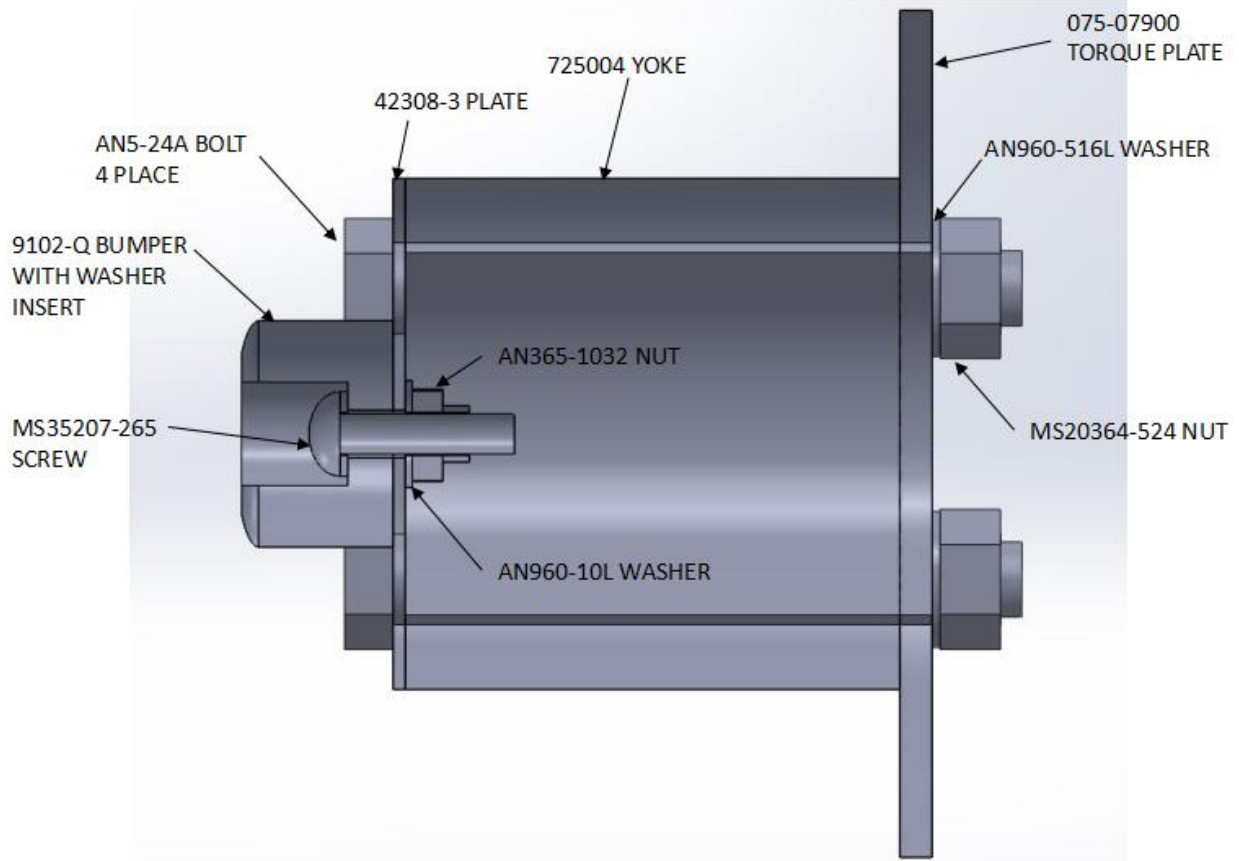
Figure 1

Determine that the AN5-24A bolts(4) are installed with the bolt heads on the inboard side of the Main Landing Gear yoke, common to the 42308-3 Plate(Refer to figure 1). Using an inspection mirror, determine

that AN960-516L washers and MS20364-524 nuts are installed with a minimum of 1 thread through the nut. If minimum thread protrusion is showing, no further change is required.

4. If minimum thread protrusion is not showing, replace the bolt(s) with AN5-25A bolts.
5. If bolt ends and nuts are showing on the inboard side of the Main Landing Gear yoke, the bolts must be reversed in order to provide required clearance between the Main Landing Gear and wing structure. Possibility of interference between bolt(s) with excess thread protrusion and structure must also be avoided.

Bolt thread protrusion through the nut on the now reversed bolts must be a minimum of 1 thread through the nut. For assemblies without minimum thread protrusion, replace bolts using AN5-25A bolts.

Torque all bolts per the Model 112 Maintenance Manual (60-85 IN-LBS above running torque).
