SERVICE BULLETIN NO. SB-114-37

## INSPECTION OF MAIN LANDING UPPER SIDE BRACE

MODELS AFFECTED: Model 114, S/N 14000 thru 14442; Model 114A, S/N 14500 thru 14540;  
Model 114B, S/N 14541 thru 14666; Model 114TC, S/N 20001 thru 20038

REASON FOR PUBLICATION: To inspect for cracking of the upper side brace in the area of the retraction cylinder attachment

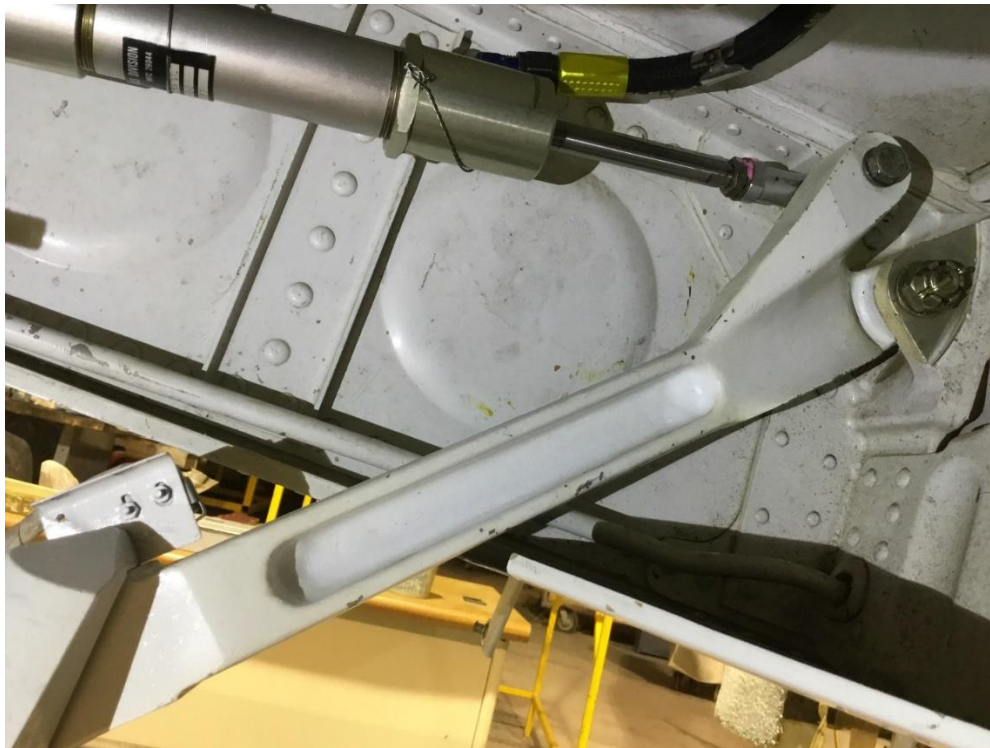
Photo 1

1. With the P/N 45303-1/-2 upper side brace in place, inspect all surfaces along the length of the link, with close attention to the upper and forward/aft surfaces in the transition area of the retraction cylinder lug.

Reference photos, 1, 2 and 3 for general location (R/H side shown). If close visual inspection shows no indication of cracking, proceed to compliance.

2. If close visual inspection indicates possible cracking of the link, proceed to further inspection by performing dye check of the suspect area, or by additional methods as may be required.

4. If the further evaluation of the P/N 45303-1/-2 side brace assembly considers it to be not repairable, replace it with a serviceable part.
